DECAY DETECTION ON THE MAIN STEM OF A CEDAR OF LEBANON TREE AT CEDAR CLOSE, WORTON September 2020

Cedar of Lebanon - *Cedrus libani* - Height 18m; Diameter 1750mm; 5 major limbs

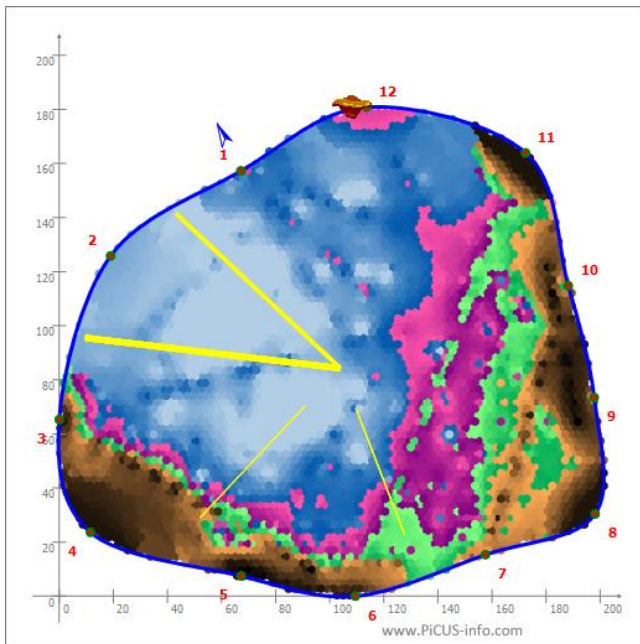
The limb growing to the southwest shows a large bark wound at 8m above ground level. Old hanging chains were noticed in the crown, probably from an old swing. Also, old pieces of iron bracing were found on the ground, but not seen in the crown. The crown was sparse, with areas of die back and minor deadwood.

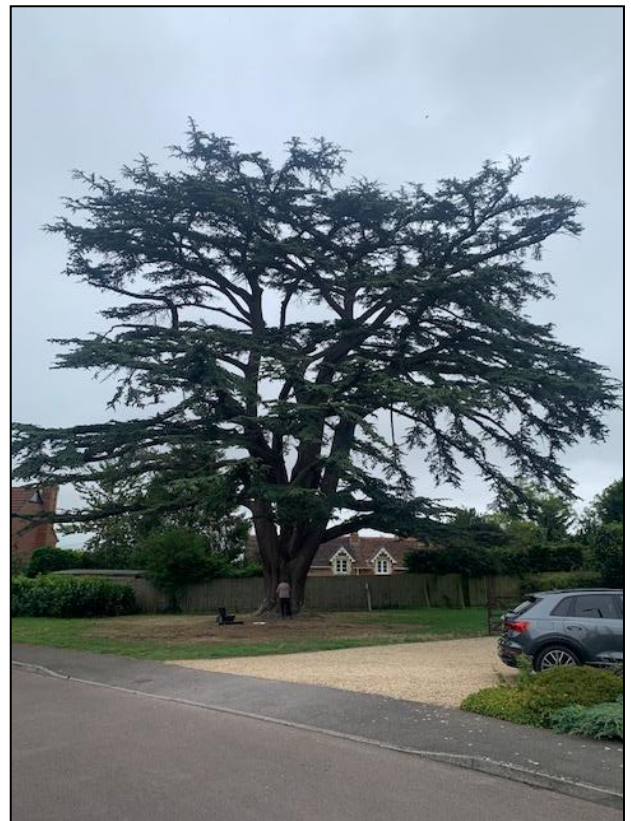
- Brown** = Good wood
- Green** = Early decay (or included bark)
- Pink** = Advanced decay
- Blue** = Cavity **Picus Sonic Tomography**

Conclusion: The Tomograph showed a large cavity coloured blue with some advanced decay coloured pink and early decay coloured green. The yellow lines are where the software indicates there could be cracks. The thicker the line, the larger the crack. The sonic data shows that there are cracks. These cracks are naturally occurring in this species of tree and increase with maturity.

This was a significant tree and showed prominently on the village skyline. The tree had already been significantly reduced, which may have been in part responsible for its lack of vigour and die back. The house near the tree was within target range of the tree.

This tree was at the end of its growing life, the cracks will not necessarily increase. The fungus observed at the base of the tree predominantly affected the root structure which could also attribute to the sparse crown. As a result of the report, the tree was felled in April, and a replacement planted.
