DECAY DETECTION ON THE MAIN STEM OF A CEDAR OF LEBANON TREE AT CEDAR CLOSE, WORTON September 2020

Cedar of Lebanon - *Cedrus libani* - Height 18m; Diameter 1750mm; 5 major limbs

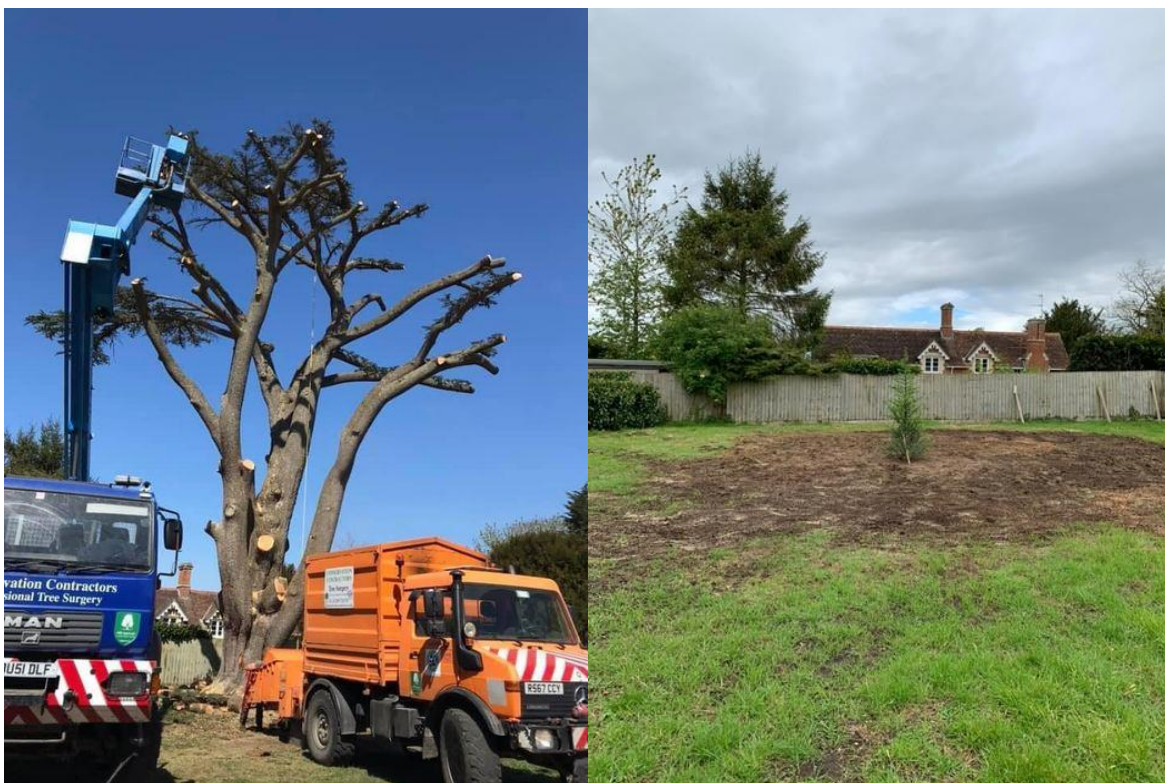
Conclusion: The Tomograph showed a large cavity coloured blue with some advanced decay coloured pink and early decay coloured green. The yellow lines are where the software indicates there could be cracks. The thicker the line, the larger the crack. The sonic data shows that there are cracks. These cracks are naturally occurring in this species of tree and increase with maturity.

This tree was at the end of its growing life, the cracks will not necessarily increase. The fungus observed at the base of the tree predominantly affected the root structure which could also attribute to the sparse crown. As a result of the report, the tree was felled in April, and a replacement planted.
